**The Village of Lions Bay,
Natural Hazards Development Permit Area Strategy:
Coastal, Creek and Hillslope Hazards.**

Submitted by
Cordilleran Geoscience
PO Box 612,
Squamish, BC
V8B 0A5

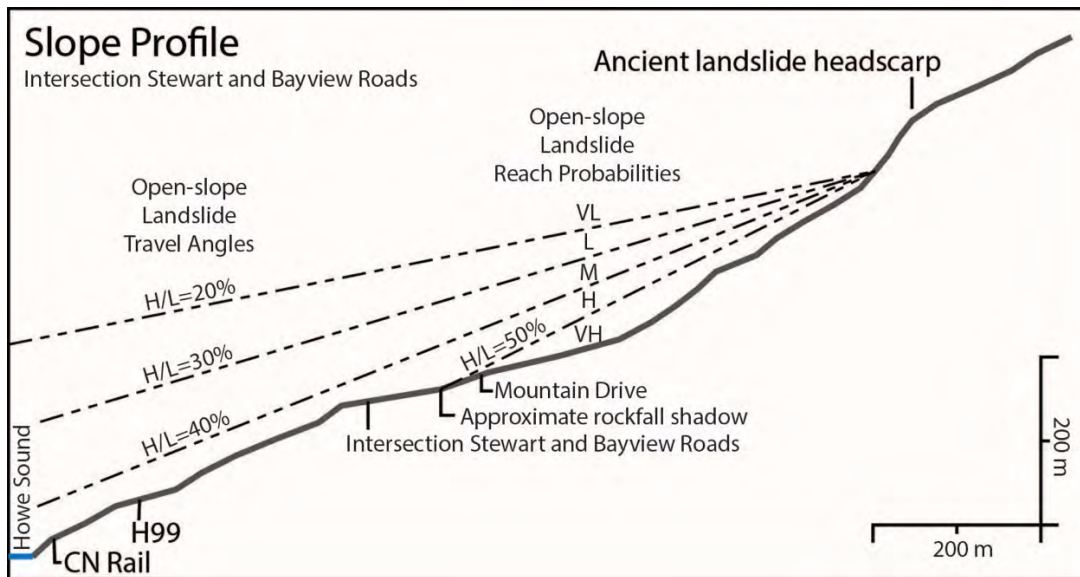
On the basis of the analysis above, to reduce the probability to no less than tolerable (1:10,000 per annum) of Type 1 error, that is, declaring a site free of hazard when in fact hazard exists, it was determined that the lower boundary for the open-slope DPA 3A should be established using the lower limit of the Low reach probability category, equating to an H/L of 20% (11⁰). Projecting this slope from some potential start zone high on the slope above the subject property captures essentially the entire municipality (Figure 4).

Figure 4. Topographic slope profile through the intersection of Stewart and Bayview Roads. Open-slope travel angles are plotted from a hypothetical start zone on the slope below the cliff and show that runouts can extend very far down the slope.

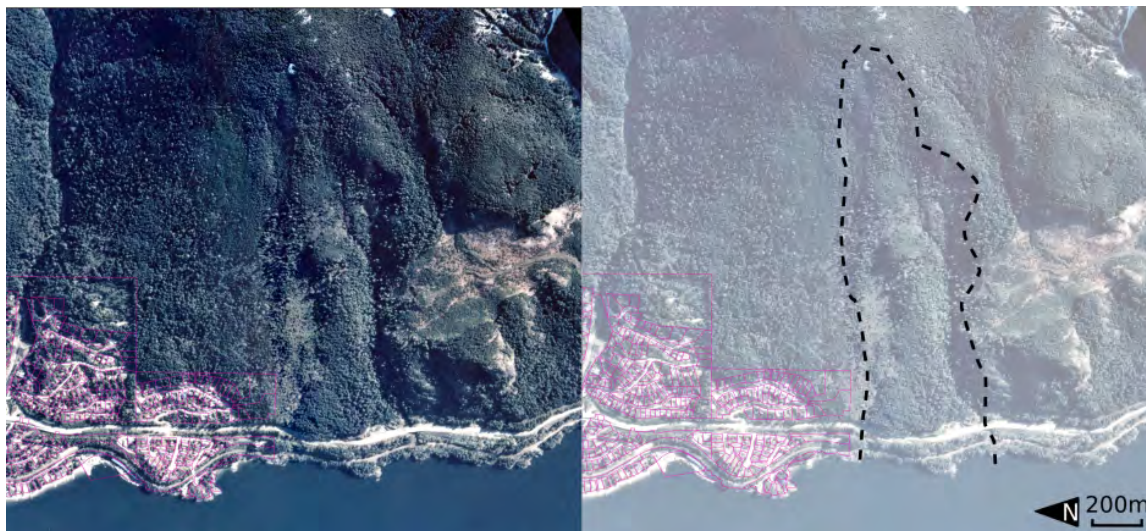
Just 100 m south of the Village of Lions Bay, the whole slope from sea level to 1100 m elevation shows signs of weakness. The area is sided by two linear depressions defining an area about 500 m width and delimited by a horseshoes-shaped headscarp at the top and by a convex toe at sea level (Figure 5). The convex toe dictates the highway path. The stability of this feature is unknown. This area is outside the LIDAR coverage but it has been recognized and mapped on the historic orthophotos. In personal communication, this area was previously identified to Cordilleran Geoscience by Karen Savage, P.Eng., of Horizon Engineering. Even if this feature might not directly affect Village of Lions Bay, it affects the highway and may pose significant hazard to the access to the Village of Lions Bay.

Figure 5. Potential sacking slope identified just south of Village of Lions Bay.

These examples of potential deep-seated instability require characterisation and assessment by a qualified geological engineer.

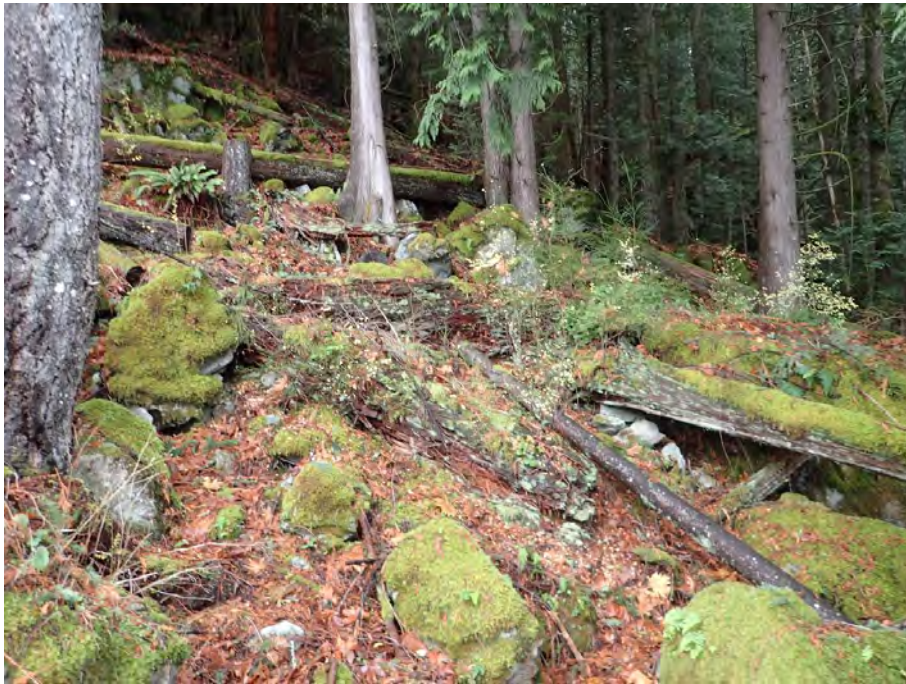
Photo 3. Blocky talus slope on Lots 60-61, Kelvin Grove Way.

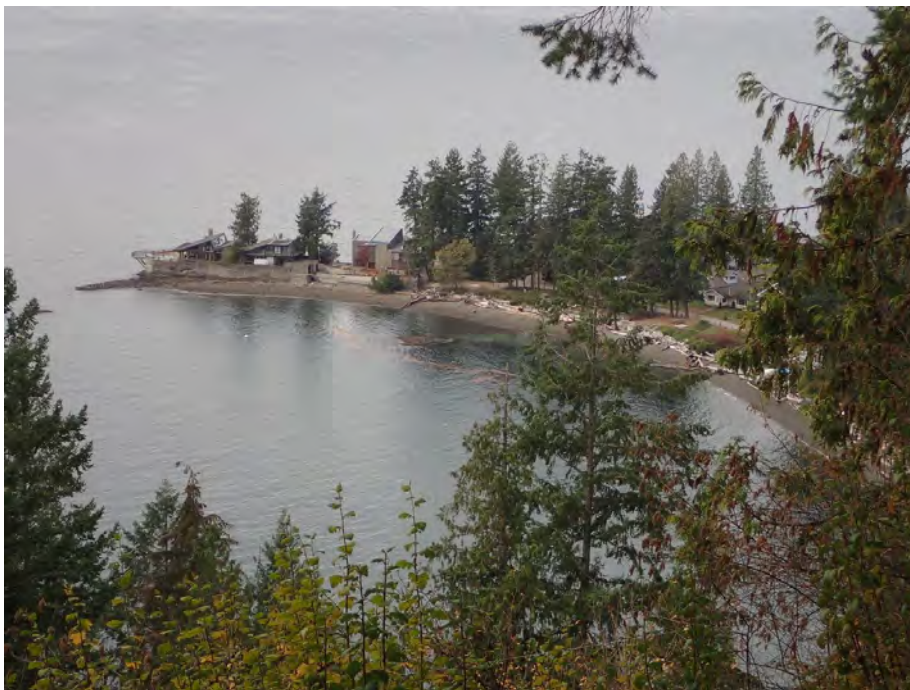
Photo 4. View of the tombolo spit, Brunswick Beach. Low lying land is subject to flooding and erosion given sea level rise.

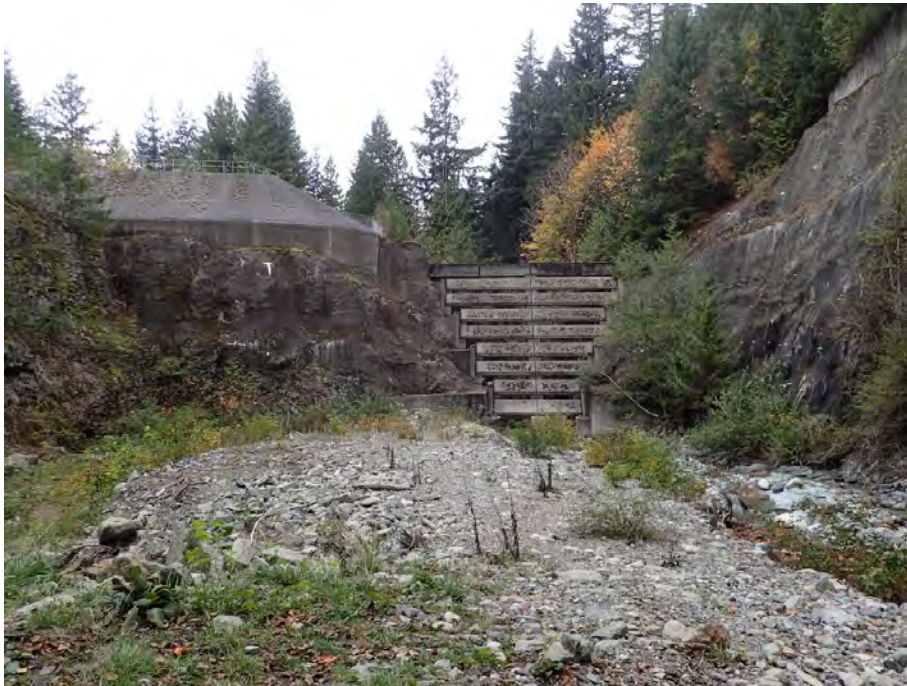
Design of mitigation for Harvey, Alberta and Magnesia (Photo 5) creek hazards in the 1980s was based on the Design Event (Table 7). Since there was no data available to prepare a debris flow frequency analysis, the Design Event was based on the “largest volume that could reasonably occur during the life of the structure” (Hung et al. 1984). The method assigned an estimated channel yield rate (m³/m) to the total channel length in the watershed; 10% might have been added to account for point sources. The storage structure volume was then made 15-25% larger than the design debris flow (Table 7). The channel works downstream of catchments were sized to accommodate twice the design event.

Photo 5. Magnesia Creek catch basin.

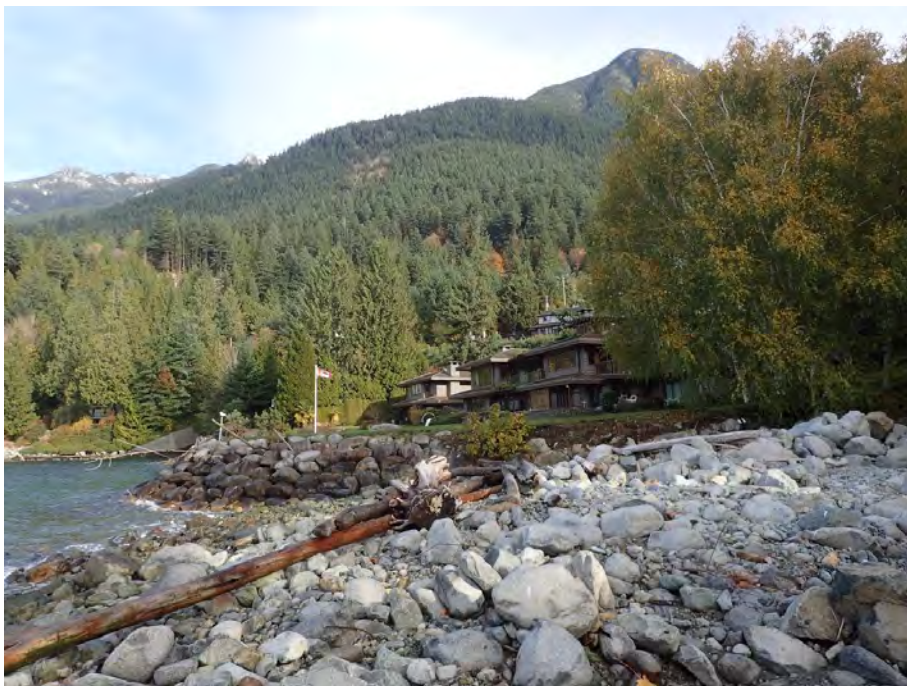
Water flood and debris flood hazard may present downstream of catchment structures as well. Where an engineered flume is present it has more than enough capacity to accommodate water floods and bulked debris floods. However, it was noted that for example on Harvey Creek, the engineered flume does not extend right to the beach, so in that area lots may be vulnerable to floods and debris floods (Photo 6).

Photo 6. Lots 21 & A Lions Bay Avenue have natural banks not significantly raised above Harvey Creek, and could be vulnerable to flood hazard.

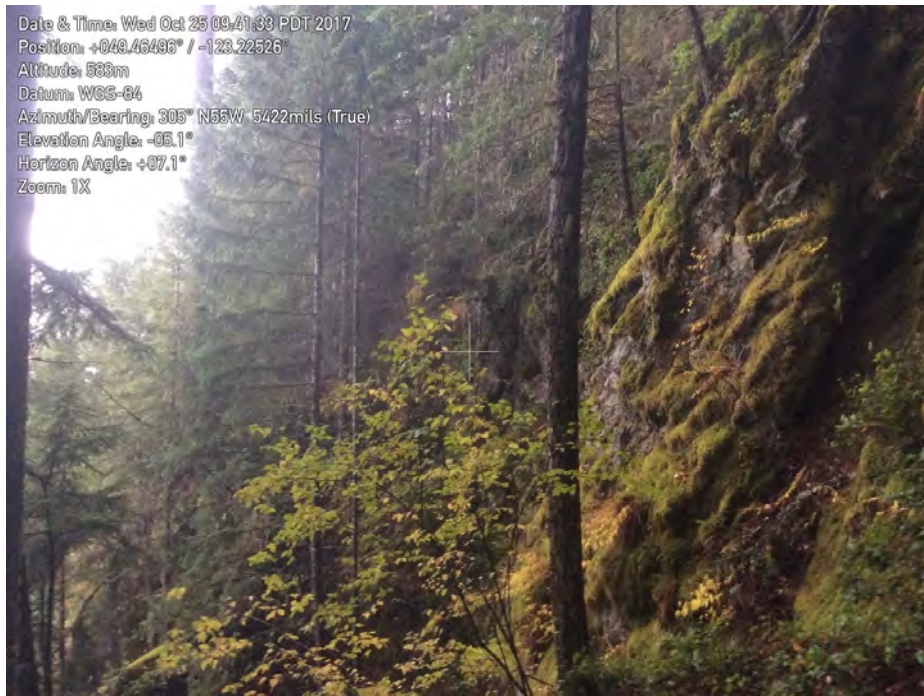
Photo 11. Bluff above Mountain Drive with unfavourable joint, parallel to steep slope.

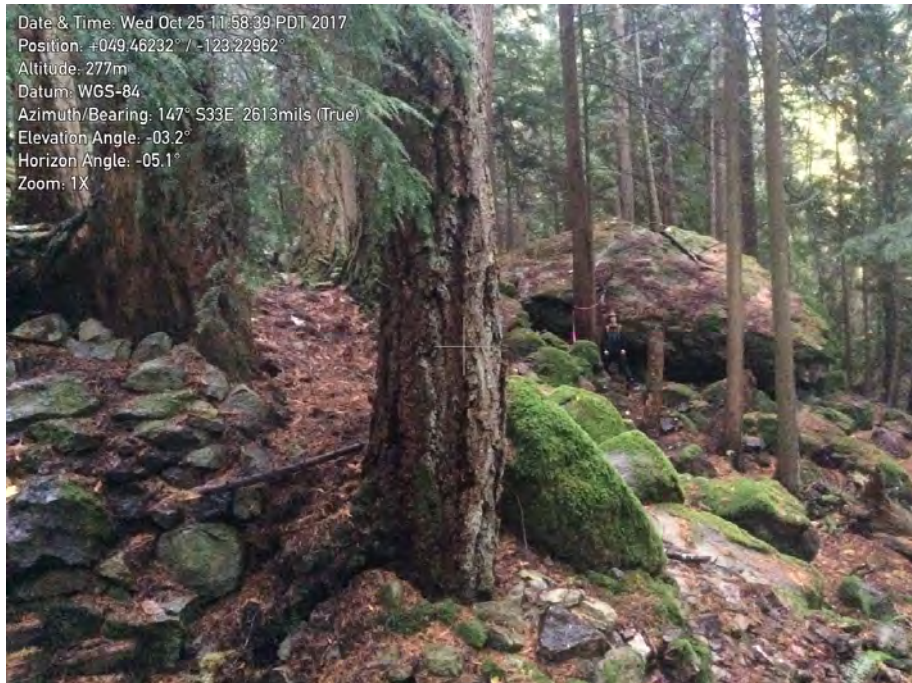
Photo 12. Rockfall debris, Lots A & B Timbertop Road. Note the person for scale.

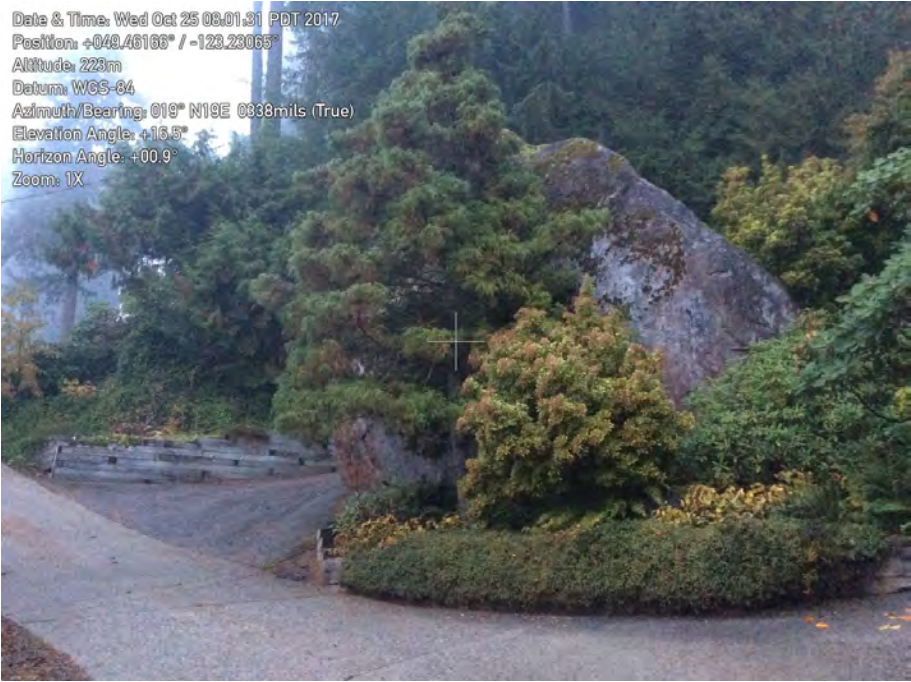
Photo 13. Rockfall block, Lot 36 Timbertop Road.

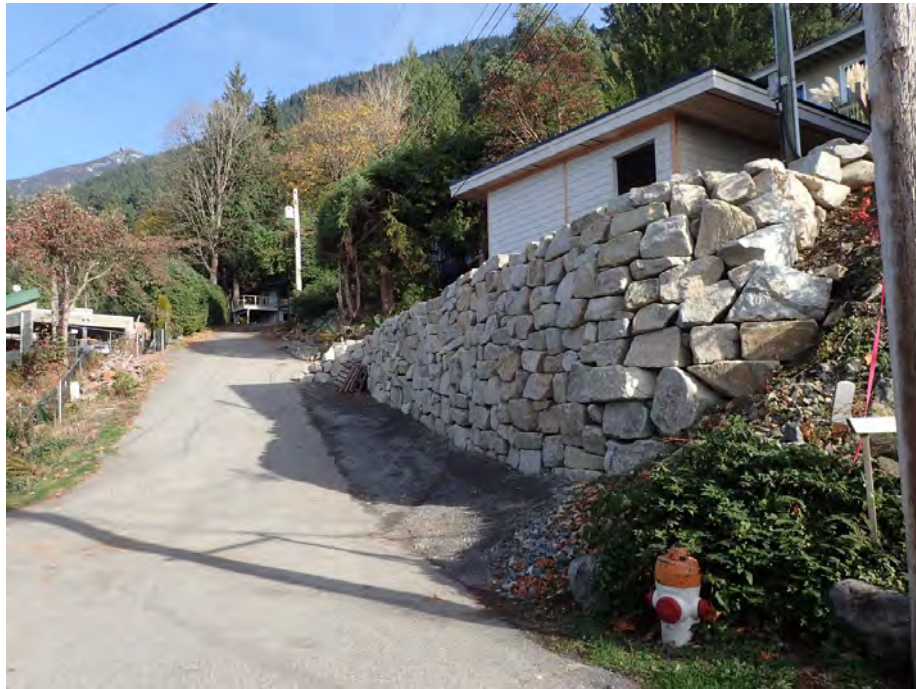
Photo 14. Lot 8 Islevue Place. Retaining walls in steep terrain require engineered design.
